SEATTLE CITY LIGHT WORK ORDER #89-6 Property Management  
1989 QUARTERLY MONITORING OF THE GEORGETOWN FLUME

LOCATION OF SAMPLING POSITIONS, GEORGETOWN FLUME

**SEATTLE CITY LIGHT WORK ORDER #89-6**  
**1989 QUARTERLY MONITORING OF THE GEORGETOWN FLUME**

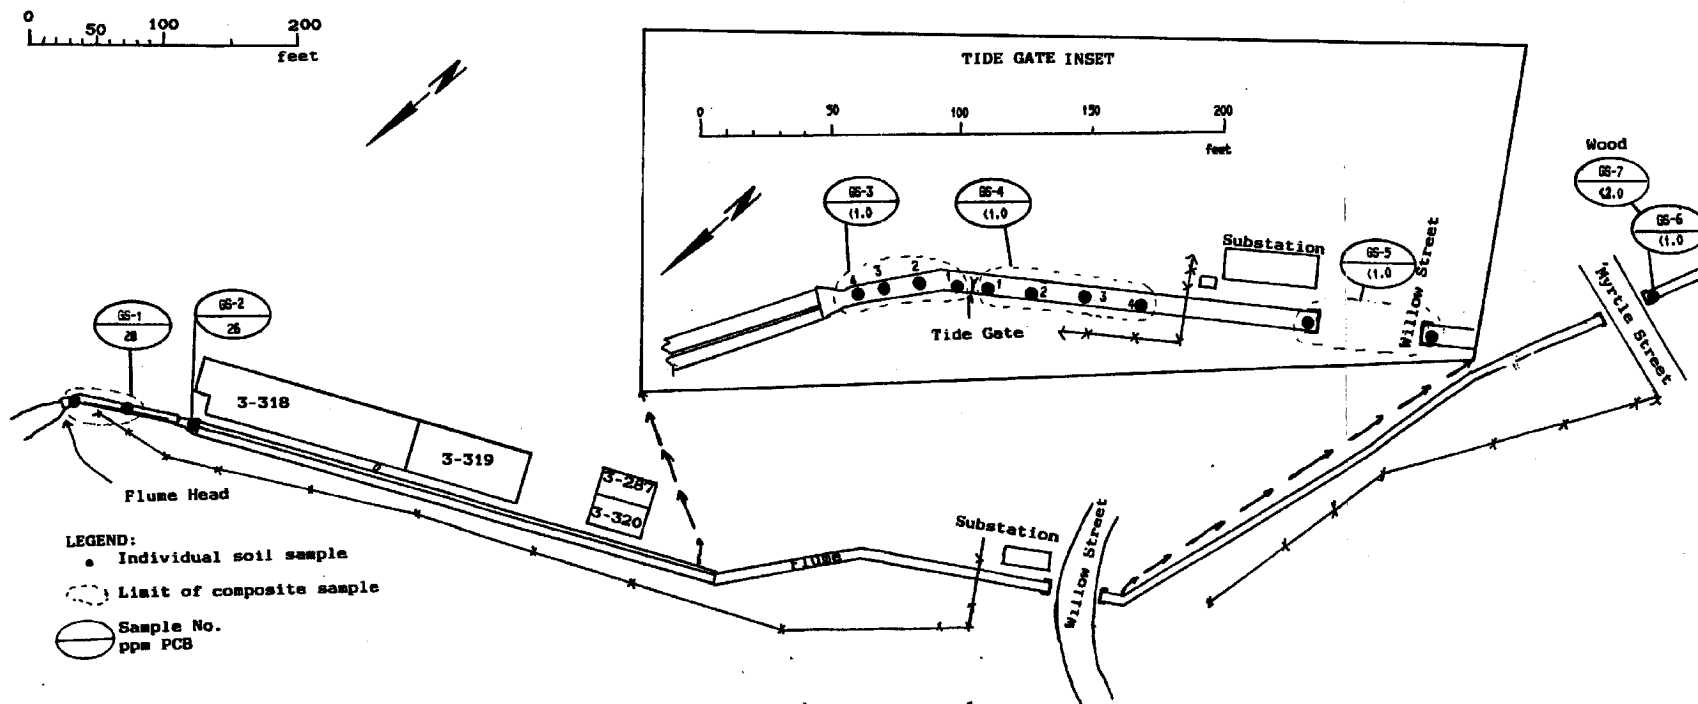
| LA TERRE ENVIRONMENTAL CONS. | DRAWING NUMBER<br><i>89-3-1/4</i> | |

| George town Flume System | | |

| <u>Sample #/<br/># Subsample</u> | <u>Location</u> | <u>Description</u> |
|---|---|---|
| GS-1 /2 | Flume head | 2" deep sediments under 10" of standing water settled clear. No oil sheen. The first inch was decayed grass in mossy yellow-brown sand. The second inch was oily black sand/silt with odors of hydrogen sulfide |
| GS-2 /1 | Double pipe | 1-1/2" deep sediments in shallow pools and patches of stagnant water. Silt with grayish black color and decayed leaves therein. |
